BOG BROOK DAM

NH 00194

PHASE I INSPECTION REPORT
NATIONAL DAM INSPECTION PROGRAM

JULY 1980

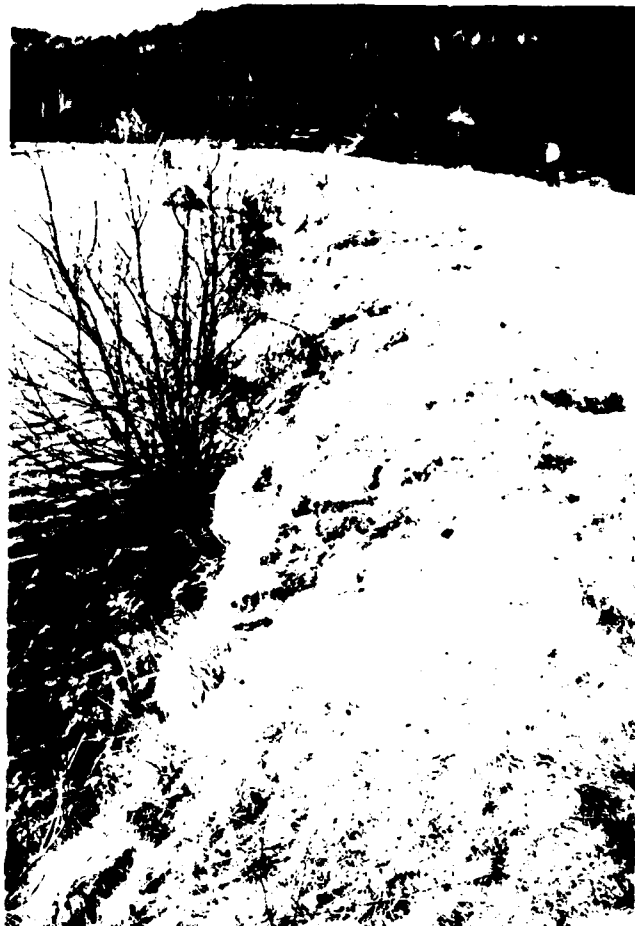
1. View of Upstream Slope Showing Sloughing
and Brush Growth

It is recommended that the services of a qualified registered professional engineer be retained to investigate the condition of the upstream slope and make recommendations for the regrading of the slope and the placement of slope protection such as riprap. The owner should implement the findings of the engineering study.

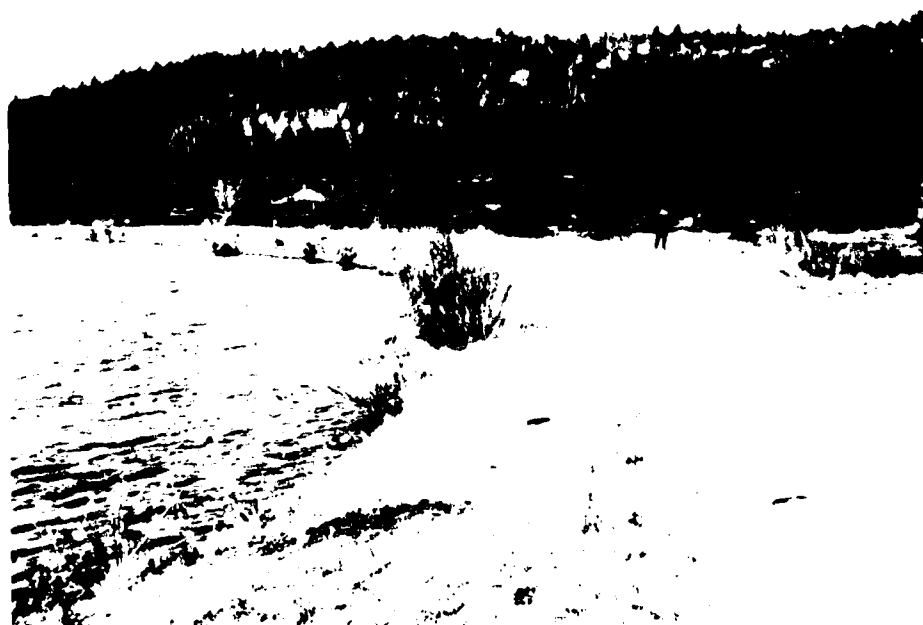
4. View from Right Abutment Showing Emergency Spillway Channel

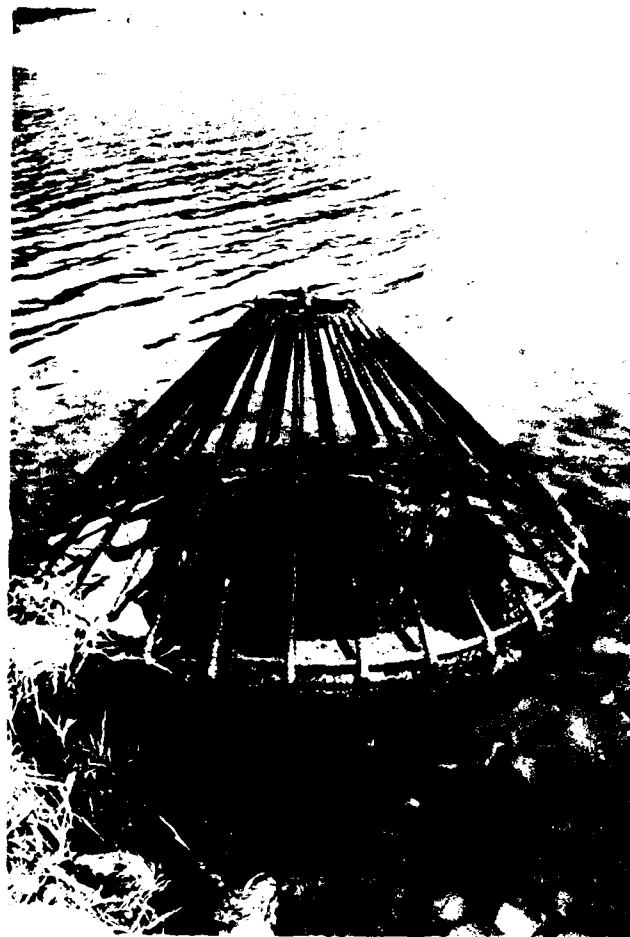
7. Principal Spillway Inlet

The spillway structure appears to be in good condition. The trash rack is clear of debris. The rim of the inlet has three slots, measuring approximately 6 inches deep, cut into it. These show signs of erosion.
